DIVISION Power Systems
TM 7972:70-640
DATE 25 August 1970
W.O. 1475-78-2000

TECHNICAL MEMORANDUM

TITLE: Evaluation of SNAP 8 Bare Refractory Double Containment Boiler No. 2
After 8700 Hours of Operation

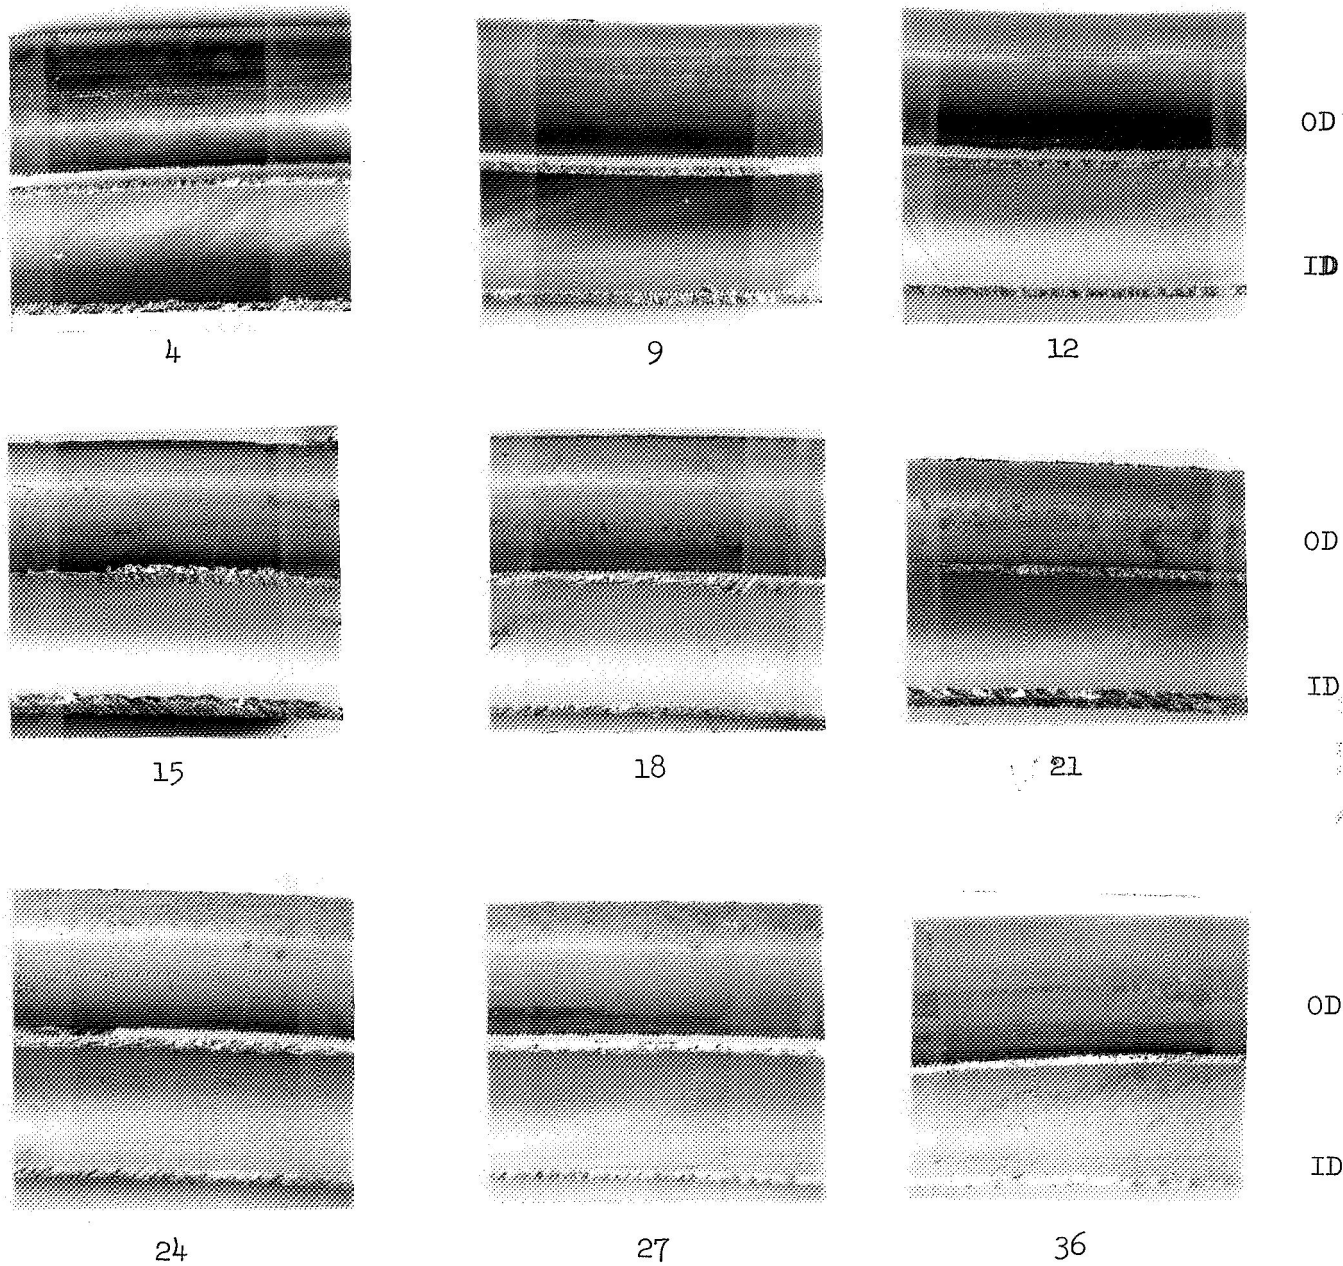
Visual examination of the O.D. of the Ta tube which had been exposed to the static NaK during boiler operation and subsequently the decontaminating solutions after removal from the PCS-1 system, revealed the presence of a black surface at the NaK outlet, Figure 1. This coloration gradually faded, and from approximately twelve feet from the NaK outlet to the NaK inlet the tube was spottily discolored in a manner indicating probable contact with the 321SS static NaK containment tube. Except for the localized wall thinning of the Ta tube under the crack in the static NaK tube, no visual evidence of corrosion of the Ta tube was detected. However, some scoring of the Ta tube O.D. was present, Figure 2, presumably due to contact with the static NaK containment tube and relative movement between the two tubes due to differential thermal expansion

Figure 1 - Appearance of I.D. and O.D. of Ta tube at various distances in feet from the Hg inlet. Approximately full size.

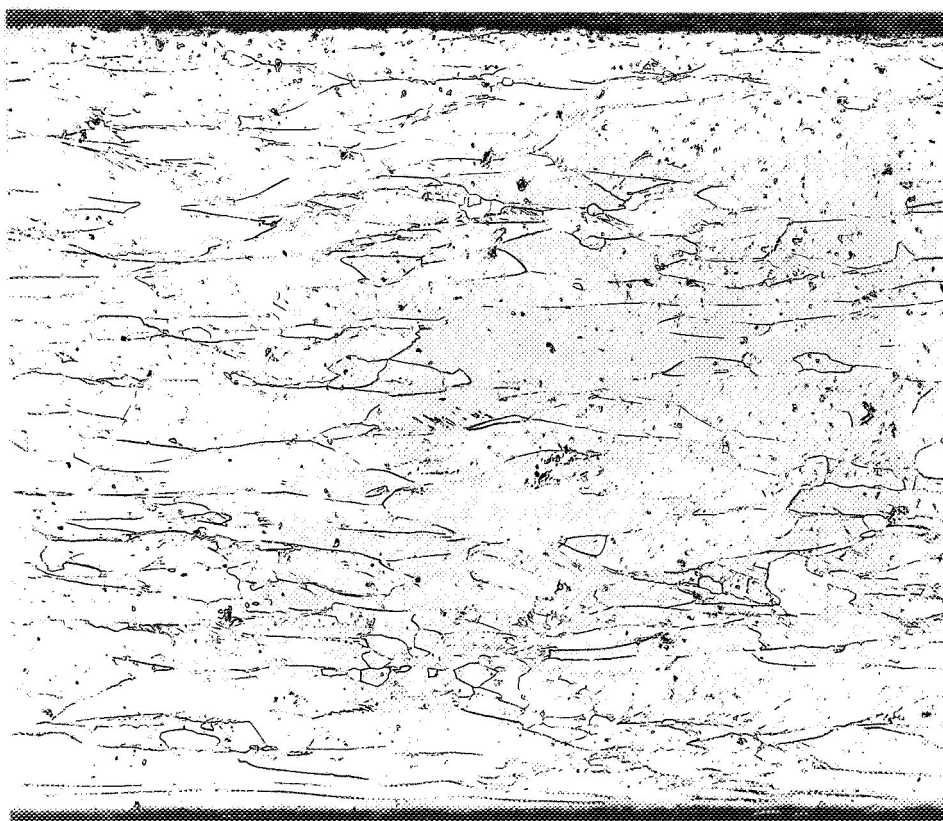
The metallographic examination revealed that Ta tubing in two different conditions was used in the fabrication of the boiler. The tubing in the straight inlet plug section and the last eight inches at the Hg outlet was recrystallized, but the tubing from the tube-to-tube weld at the end of the plug section to the tube-tube weld near the Hg outlet of the boiler was in the cold-worked condition, Figure 4. From the elongated grain structure produced by the cold-working, it was estimated that the Ta was cold-worked approximately fifty percent. The cold-working increased the hardness of the Ta tube as revealed by the microhardness traverses performed, Table II. The average Knoop hardness of the cold-worked material was 147 KHN (130-158 KHN range) and of the unswaged recrystallized tubing at the inlet was 108 KHN (102-113 KHN range). The only area of the parent metal tubing which exhibited a true hardness gradient was the inlet end where it had been swaged over the plug. The hardness in this area was as high as 296 KHN at the surface with an average cross sectional hardness of 151 KHN. This hardness gradient was produced by the cold-work introduced into the recrystallized Ta by the swaging operation. The cold-worked tubing comprising most of the length of the boiler tube did exhibit a variation in hardness across the wall thickness, but the pattern was not uniform and could not be interpreted as a through-wall gradient. In general, the O.D. did tend to be slightly harder than the I.D., but this was not true at all locations tested. In some areas, the center of the wall thickness was harder than either the I.D. or the O.D. If oxygen contamination of the Hg loop had occurred, a decreasing hardness gradient from the I.D. to the O.D. of the Ta tube wall would be anticipated. Therefore, it is presumed that the Ta wall hardness variation was due primarily to the previous cold-work history of the Ta tube. Cold-worked Ta exhibits lower ductility than recrystallized Ta; the ductility decreasing with increasing amounts of cold reduction. Although mechanical tests were not performed to determine actual values, the cold-worked Ta in this boiler would exhibit lower ductility than if it had been recrystallized. Therefore, an undetermined but shorter low cycle fatigue life would be anticipated. No indications of cyclic stress failure were detected in the boiler tube, but for optimum resistance to the low cycle fatigue failure, future boilers should be fabricated from recrystallized Ta. No evidence of Hg

Figure 4 - Longitudinal cross-sections through Ta tube. Recrystallized structure from Hg inlet straight section, top; and cold-worked structure 18 feet from Hg inlet 100X, Glyc + HF + HCl + HNO₃ etch.

5. Although no indications of initiation of failure of the Ta in the BRDC #2 boiler were detected, future boilers should be constructed of recrystallized rather than cold worked Ta to provide greater ductility of the material and to reduce the possibility of failure due to low cycle fatigue and hydrogen or oxygen embrittlement.

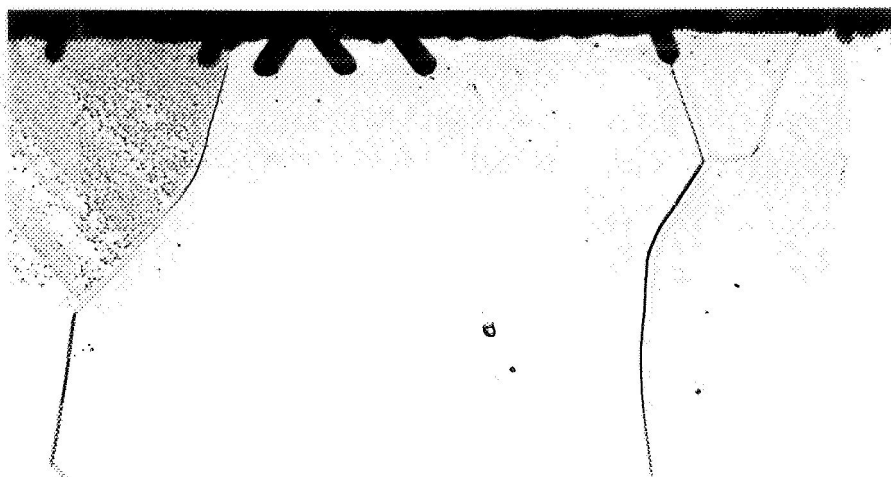
4. General NaK corrosion of the Ta did not occur but NaK removal of oxides from the heat affected zone of two welds with resultant void formation occurred. The presence of the original oxide was the result of insufficiently pure protective inert atmosphere during the welding operation. This indicates that the static NaK concept is effective and that NaK corrosion of the Ta is not life limiting.

Figure 6 - Longitudinal cross-section through heat affected zone of Ta tube weld 36 $\frac{1}{2}$ feet from Hg inlet. Crevices in O.D. surface were produced by NaK corrosion along grain boundaries and preferential crystallographic planes and was caused by oxygen contamination during welding.

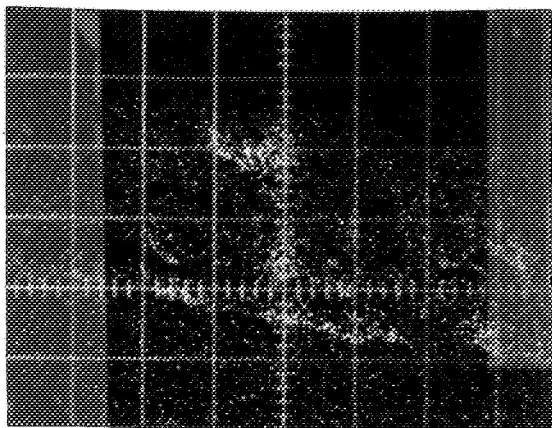
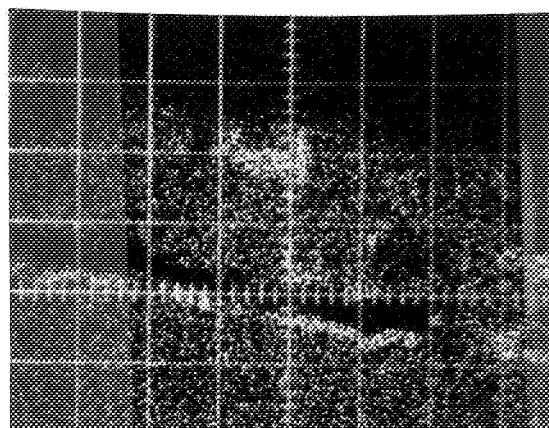
Figure 9 - Radiation displays of I.D. of Ta tube 15 feet from Hg inlet header showing distribution of Ta, Ni, Fe, Cr, and Co. 340X
See Figure 10 for another display from another circumferential location on same tube cross-section.

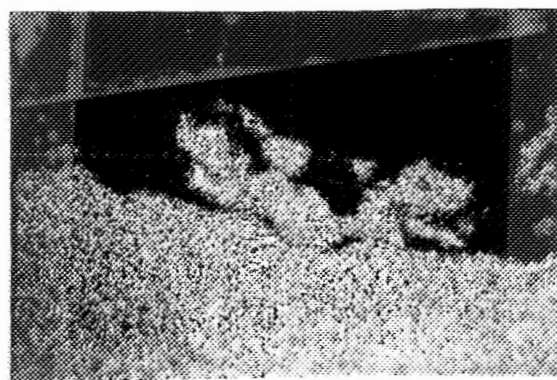
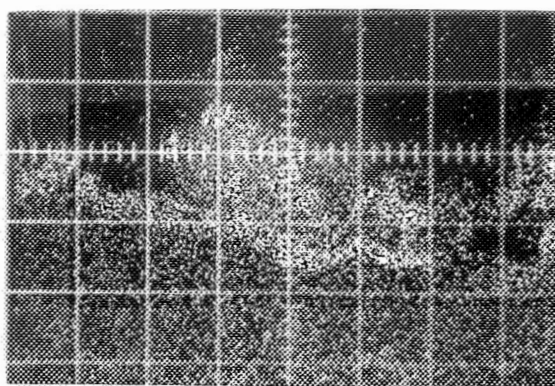
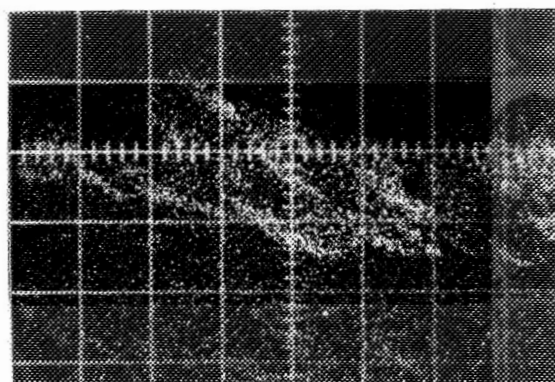
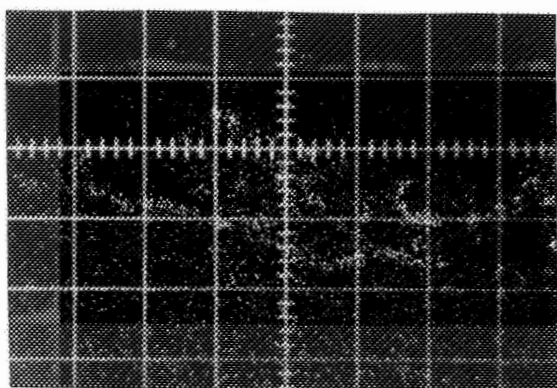
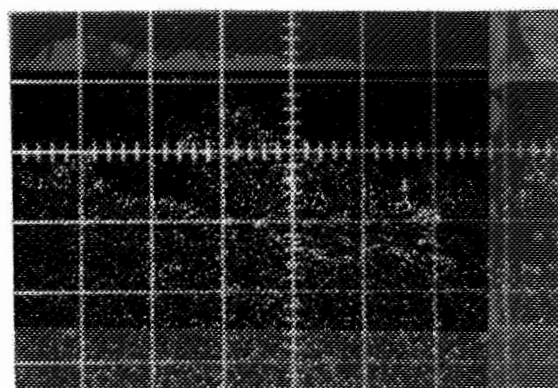
Figure 10 - Radiation displays of I.D. of Ta tube 15 feet from Hg inlet header showing distribution of Ta, Ni, Fe, Cr, and Co. 340X

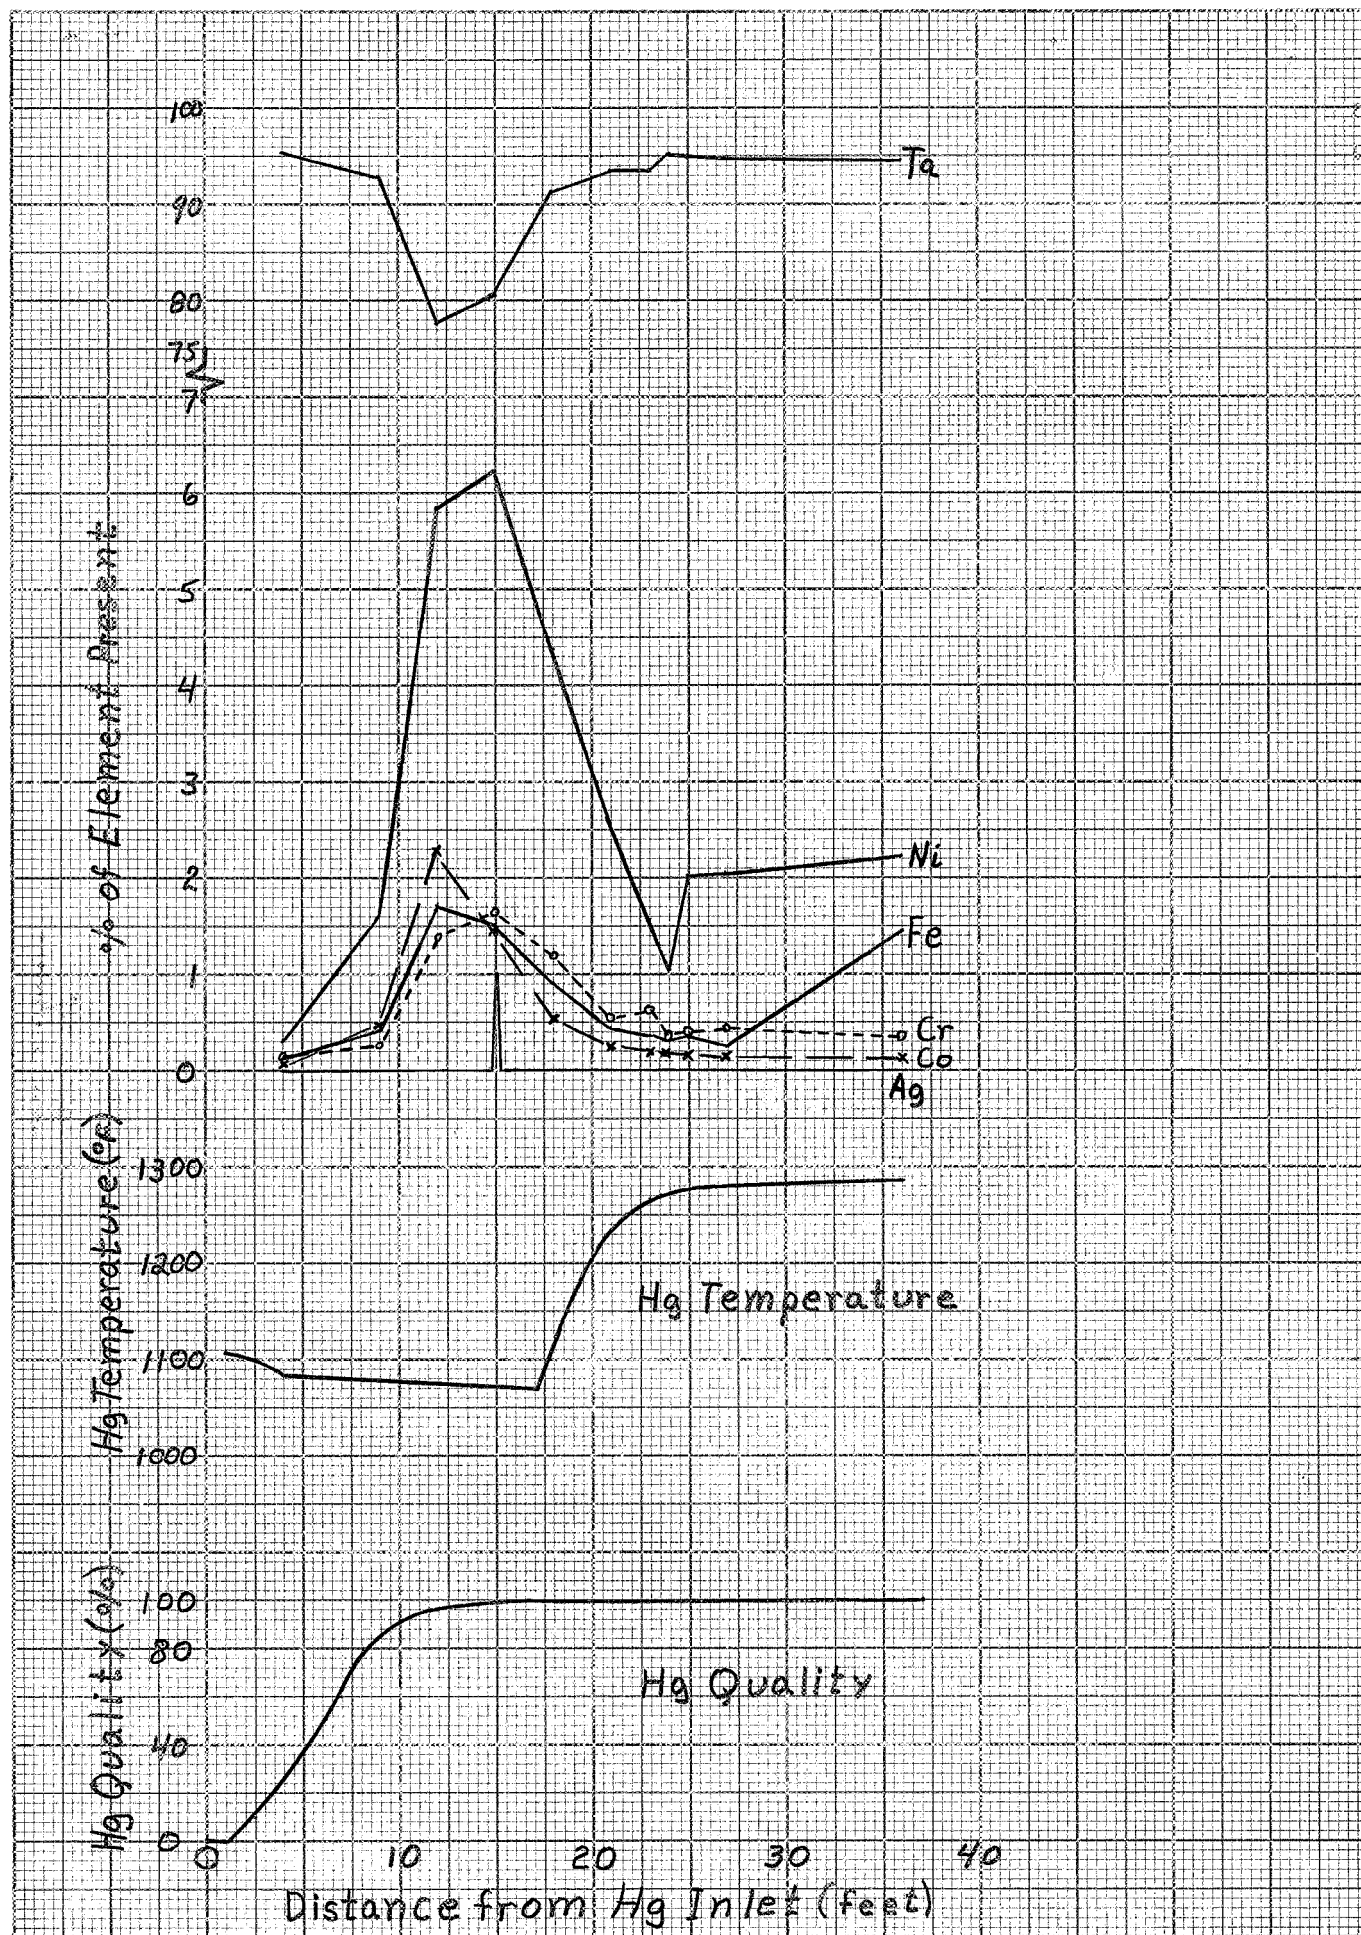
A pattern of mass transfer product deposition was present along the length of the Ta tube from the Hg inlet to the outlet. This was observed by a difference in the X-ray fluorescence analyses of flattened tube I.D. surfaces at various locations along the length of the tube, Figure 12. The fluorescence analyses indicated not only a difference in thickness of the deposits but also a change in composition at the various locations. These analyses correlate well with the condition of the Hg during boiler operation. In the plug region of the boiler where the cold incoming Hg was being heated and boiling initiated, no deposits were detected metallographically. By scraping the I.D. surface of the straight Hg inlet tube, and thus providing a concentrated sample the presence of small quantities of Fe, Ni, and C was established. As the quality of the Hg increased farther into the boiler, the amount of deposits present increased until

Fig.12.Composition of I.D. of Ta Tube as Determined By X-Ray Fluorecence Analysis.

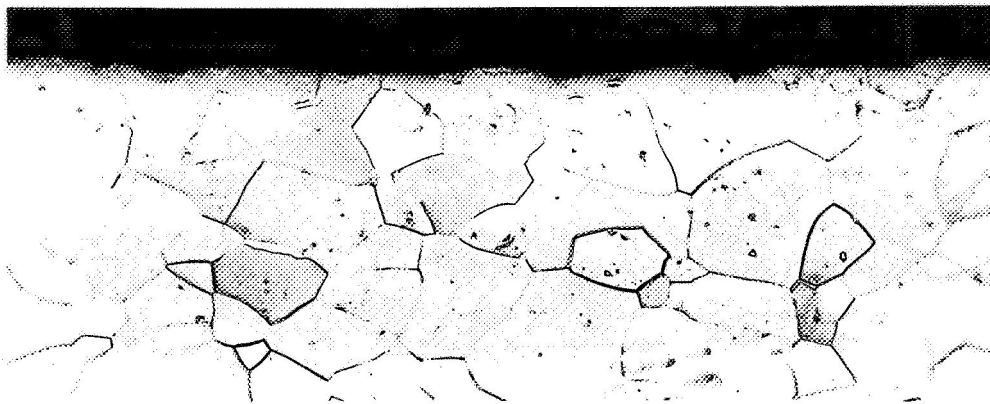
The O.D. of the Ta dome had surface tears, extending 0.003 inches into the wall, which probably occurred during the fabrication of the part, Figure 15. These defects did not appear to have propagated during system operation and although they are undesirable, do not appear to have caused any adverse effects on boiler operation.

Figure 15 - O.D. surface of Hg inlet Ta dome exhibiting surface tears produced during fabrication.

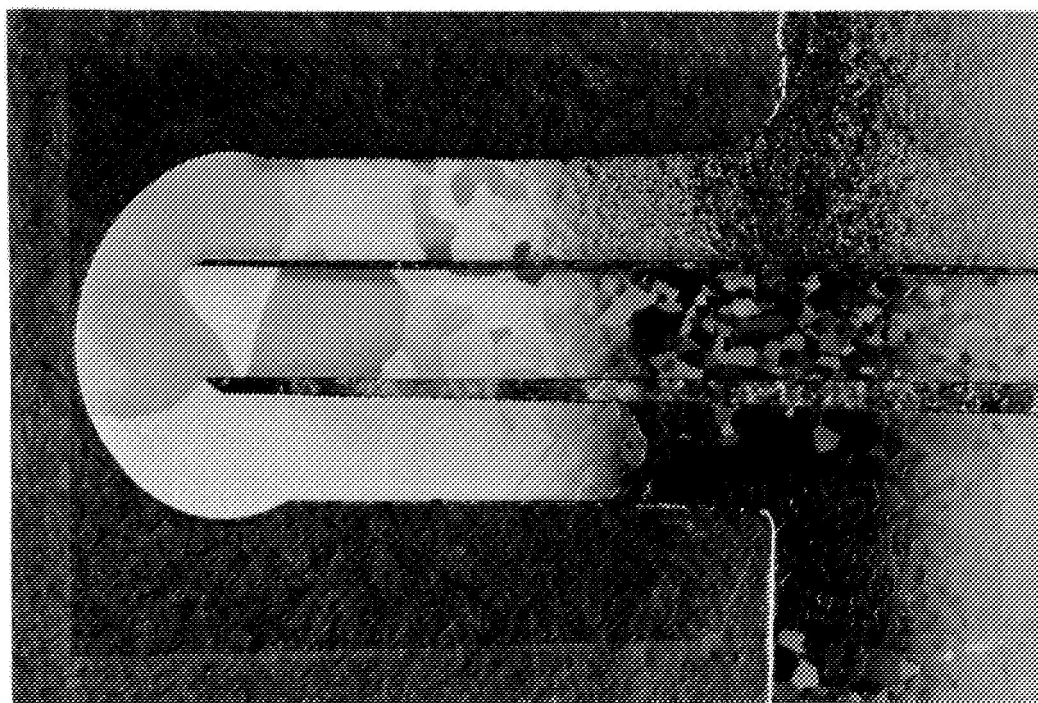
A section of the Ta tube-header-orifice weld at the Hg inlet was examined metallographically, Figure 17. No defects were detected; however, the wall thickness of the tube in the weld metal consisted of only one grain. The hardness of this weld averaged 130 KHN with the Hg exposed surface being 129 KHN and the core being as high as 140 KHN. This is the same condition that existed at the outlet tube to header weld except at the inlet header the hardnesses were somewhat higher. No indications of corrosion, erosion or mass transfer product deposition were detected metallographically.

Figure 17 - Ta Tube/Orifice/Header weld at Hg inlet
